DEPARTMENT OF TRANSPORTATION

Office of Structural Materials

Contract #: 04-0120F4Cty: SF/ALA Rte: 80 PM: 13.2/13.9File #: 99.28**WELDING INSPECTION REPORT****Resident Engineer:** Siegenthaler, Peter**Address:** 333 Burma Road**City:** Oakland, CA 94607**Report No:** WIR-021035**Date Inspected:** 24-Feb-2011**Project Name:** SAS Superstructure**OSM Arrival Time:** 700**Prime Contractor:** American Bridge/Fluor Enterprises, a JV**OSM Departure Time:** 1900**Contractor:** Zhenhua Port Machinery Company, Ltd (ZPMC) Chanxing Island**Location:** Shanghai, China**CWI Name:** Mr. Qui Wen**CWI Present:** Yes No**Inspected CWI report:** Yes No N/A**Rod Oven in Use:** Yes No N/A**Electrode to specification:** Yes No N/A**Weld Procedures Followed:** Yes No N/A**Qualified Welders:** Yes No N/A**Verified Joint Fit-up:** Yes No N/A**Approved Drawings:** Yes No N/A**Approved WPS:** Yes No N/A**Delayed / Cancelled:** Yes No N/A**Bridge No:** 34-0006**Component:** OBG Segment**Summary of Items Observed:**

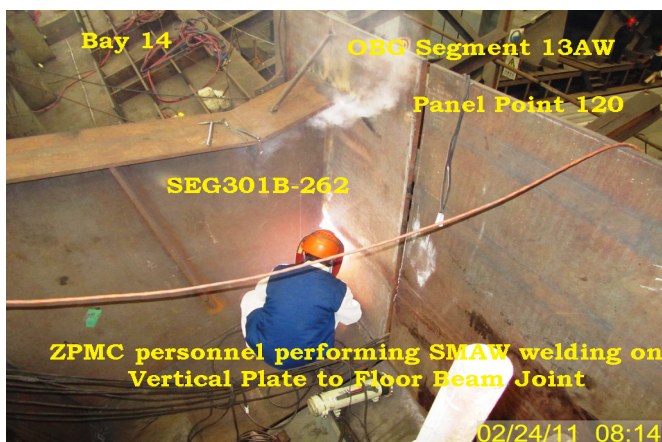
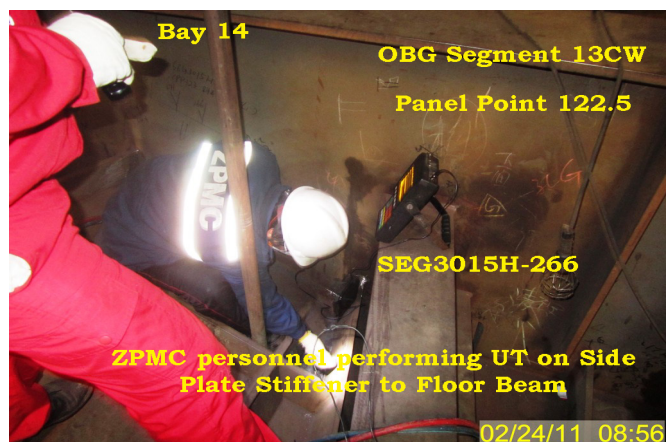
This QA inspector observed ZPMC personnel performed Ultrasonic Testing on Side Plate I-stiffener to Floor Beam 'T' joint weld at panel point 122.5 of OBG Segment 13CW. The weld number is identified as SEG3015H-266. See the attached pictures.
